RAINFLOWER · YOUTH RESEARCH · CRA — EFFECTS OF RAIN

# Effects of Rain — what a strong submission looks like

## Standing water at the mouth of a roadside drain

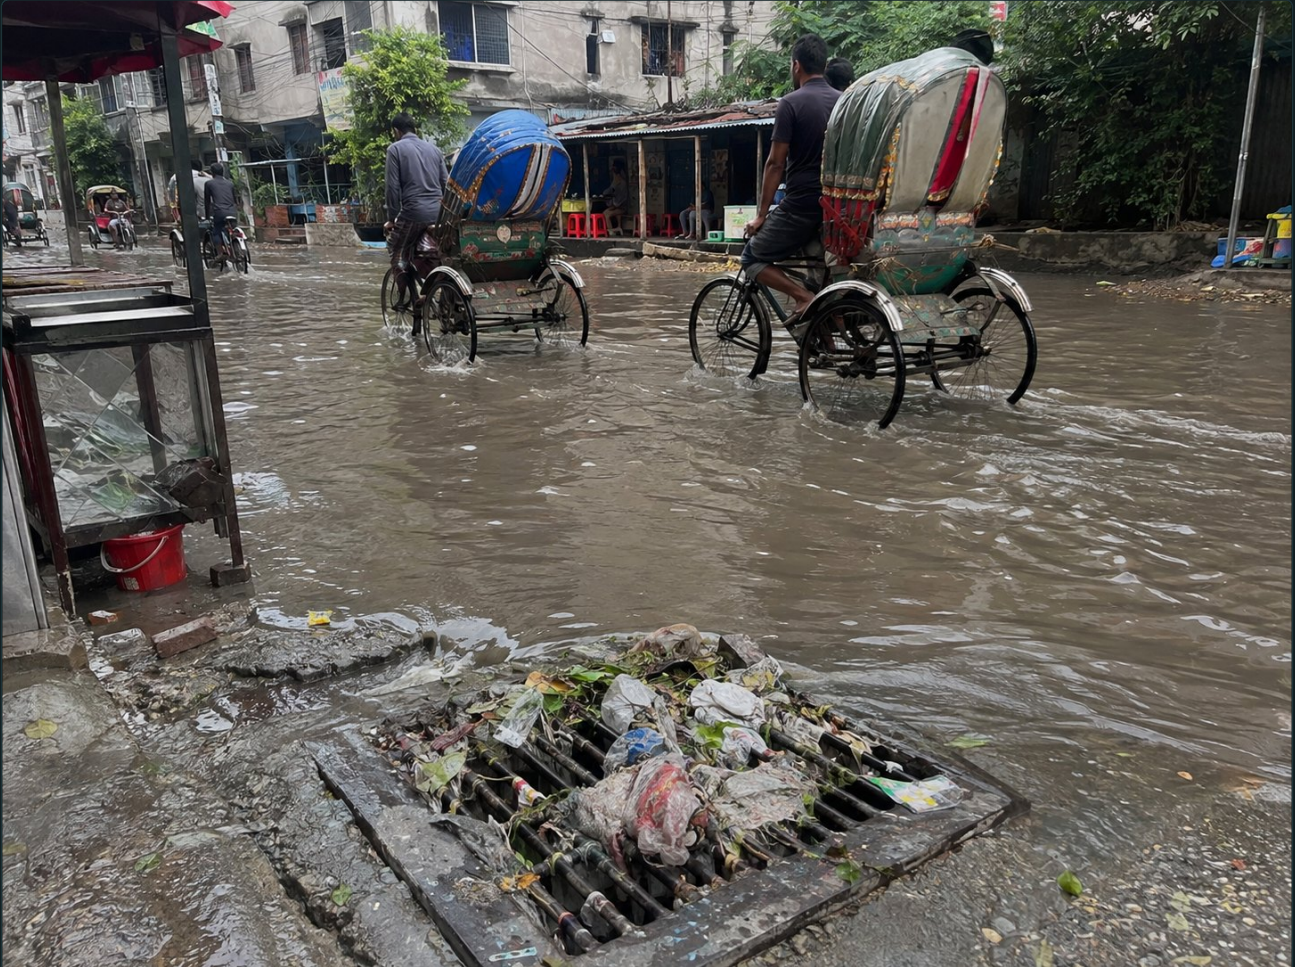
FIG. 1 · 4:30 PM

Water covers the road from the drain opening to the opposite kerb, approximately 4–5 metres wide. Leaves, plastic bags, and a torn cement sack are visible at the drain grate. The water surface is brown and still. Two rickshaws are passing through the water, and their wheels are submerged to roughly one-third of wheel height. A tea stall beside the water is open and serving customers.

It cannot show how deep the water is at the centre, whether the drain is blocked underground, or how long the water remained after this photo was taken.

Two locations held standing water two or more hours after rain ended — "Standing water at the mouth of a roadside drain" and "Waterlogged unpaved lane between houses" — and both share a feature: either visible debris at the drain opening or no drain at all. The one location that drained well, "Drain outlet where water is flowing freely," had a visibly clear grate and a paved surface. Water accumulation appears on unpaved and debris-adjacent surfaces; free flow appears where the surface is paved and the opening is clear. Separately, "Roof runoff falling directly onto the street" shows collectable water being discharged onto a footpath and flowing toward the same drain that already has standing water.

**Infrastructure.** Drains are present at three of five locations. Where the opening was clear, water moved; where debris was visible, water stood. This is consistent with openings being a factor, but the photographs cannot establish the condition of the drains underground.

My strongest conclusion is that debris at drain openings is associated with standing water. An alternative: the standing-water locations may simply be lower-lying than the free-flowing location, and would hold water even with clear grates. Another: the drain in Photo 1 may be overwhelmed by volume rather than blocked, since Photo 3 shows roof runoff feeding the same drain.

Does the drain in Photo 1 hold standing water after light rainfall as well as heavy rainfall? Answering this would need rainfall measurements from a Rainflower gauge at this location, plus repeat visits to the same drain after at least three rain events of different intensities, photographed at a consistent time interval after each event.

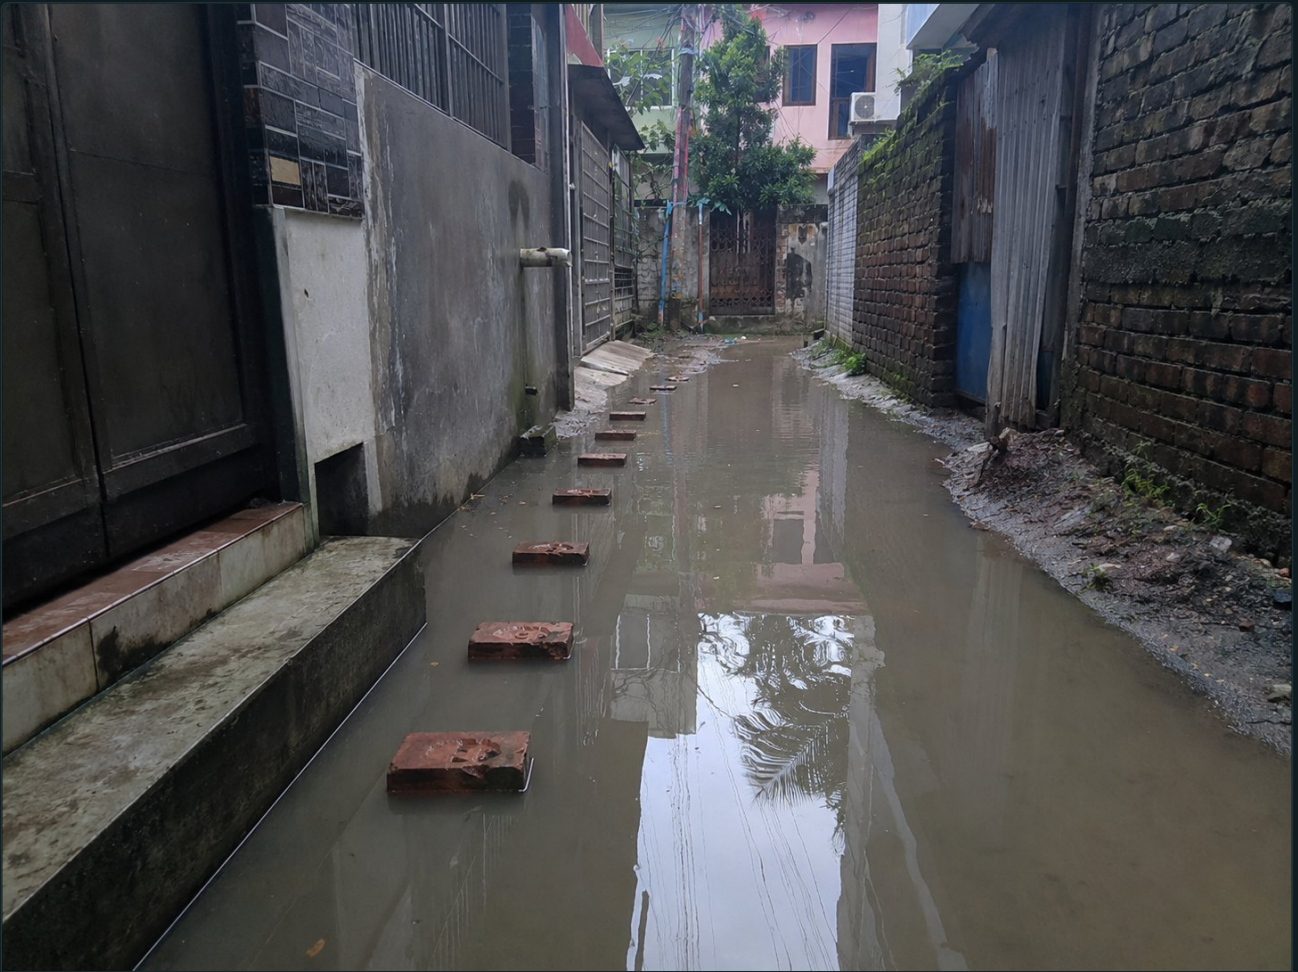
FIG. 2 · 4:45 PM

The unpaved lane holds a continuous stretch of standing water roughly 15 metres long, spanning the full width of the lane (about 2 metres). Bricks have been placed in a line along one edge, spaced about half a metre apart, and wet footprints are visible on the bricks. Water reaches approximately halfway up the lowest step of a doorway on the left.

It cannot show whether the bricks were placed today or have been there through many rains, or whether water entered the house behind the doorway.

**People.** The brick path in Photo 2 and the open tea stall in Photo 1 show residents adapting and continuing daily life through these conditions rather than being stopped by them. I did not interview residents for this set.

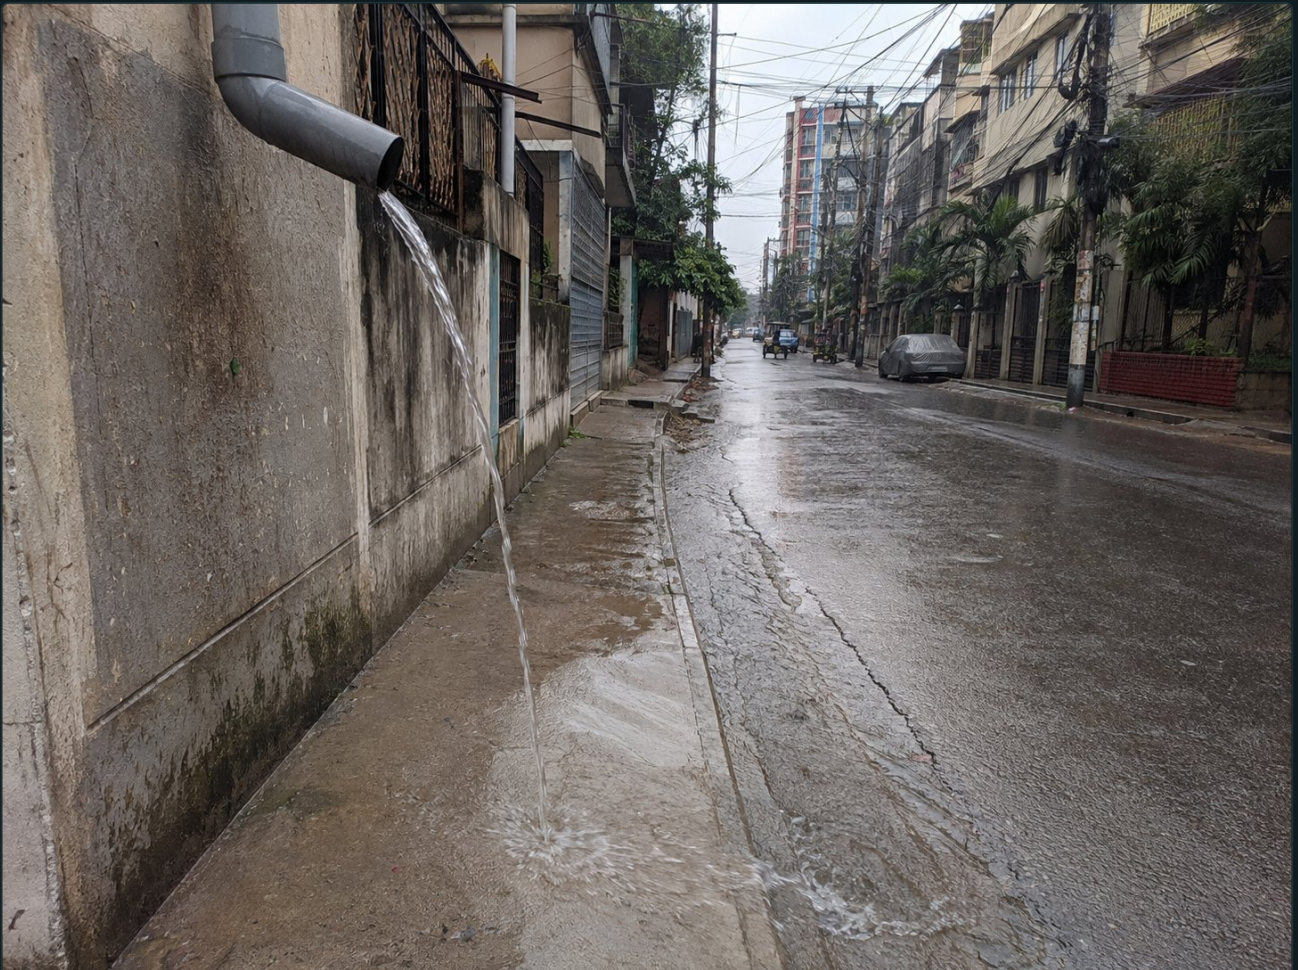
FIG. 3 • 5:00 PM

A pipe extending from a three-storey building's roofline discharges a steady stream of water directly onto the footpath. The stream has cleared a fan-shaped area of the footpath of dust, roughly 1 metre wide. Water flows from the footpath into the road and toward the drain opening shown in Photo 1, about 30 metres away. No container or collection structure is visible under the pipe.

It cannot show the volume of water discharged over the whole rainfall, or where the building's other roof outlets lead.

**Water.** Rainwater in this photo set appears as all three: a nuisance (the waterlogged lane crossed on bricks), a possible hazard (rickshaws passing through water of unknown depth), and a wasted resource (roof runoff discharging onto a footpath with no collection). The runoff photo is itself a finding: a steady, concentrated stream of water left an existing roof pipe and contributed to street accumulation instead of being captured.

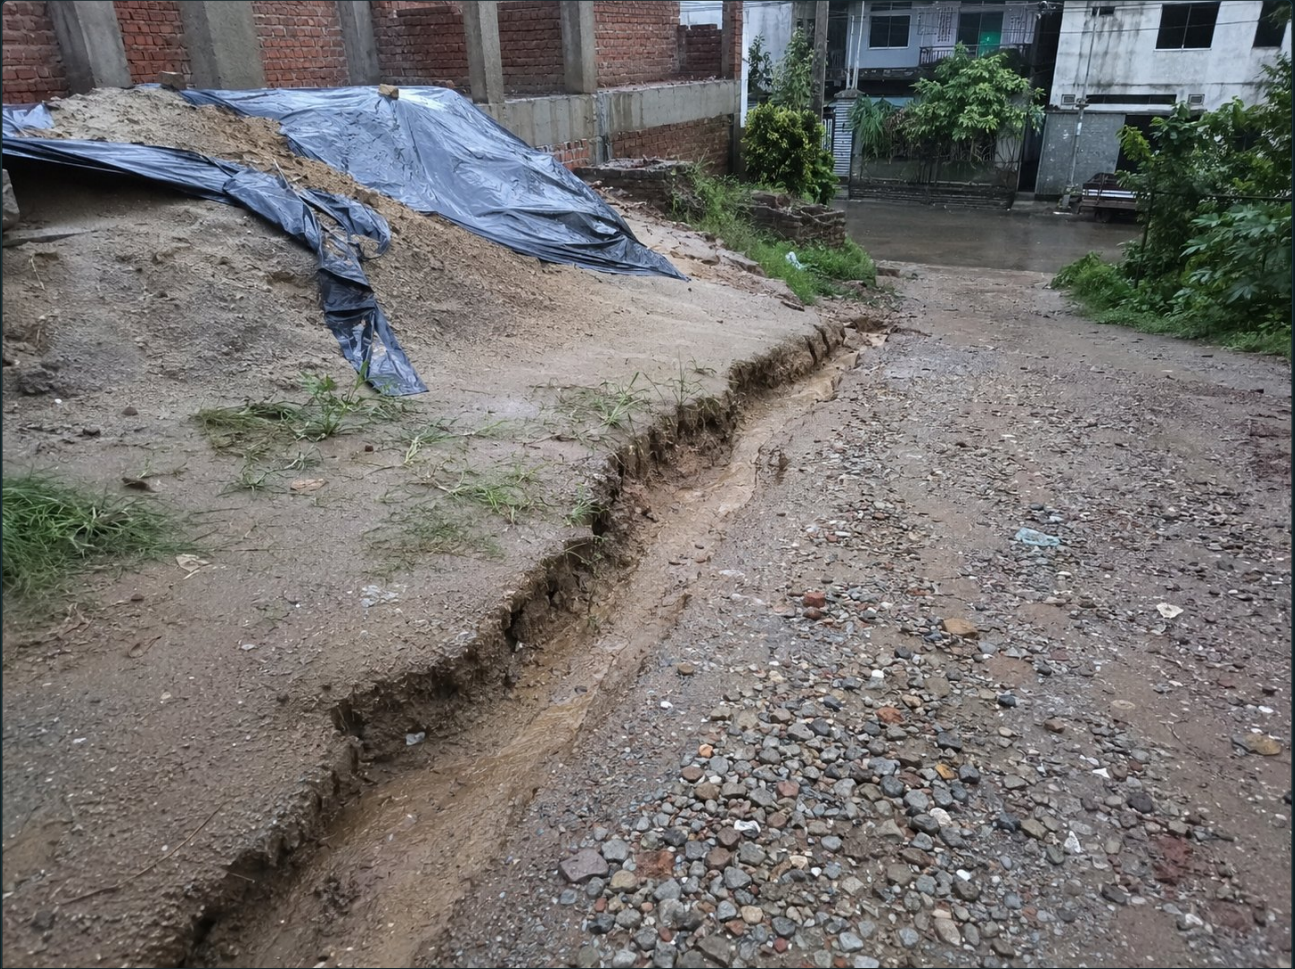
FIG. 4 · 5:10 PM

The earthen edge of the path has a channel cut into it, approximately 20–30 centimetres wide and 10 centimetres deep, running about 4 metres downslope toward the road. Sand and small gravel are spread across the path at the channel's lower end for about 2 metres. A pile of construction sand sits uphill of the channel, partially covered by a plastic sheet with one corner loose.

It cannot show whether the channel formed during today's rain or over many rainfalls, or how much of the spread material came from the construction pile versus the path itself.

This set covers one neighbourhood, one rain event, and one afternoon. There are no depth measurements, no rainfall total from a gauge (intensity is by observation only), no view of any drain below the grate, and no before/during comparison — all photos were taken after the rain had mostly ended, so I cannot show how conditions developed. Photo 4's erosion channel cannot be attributed to this single rainfall.

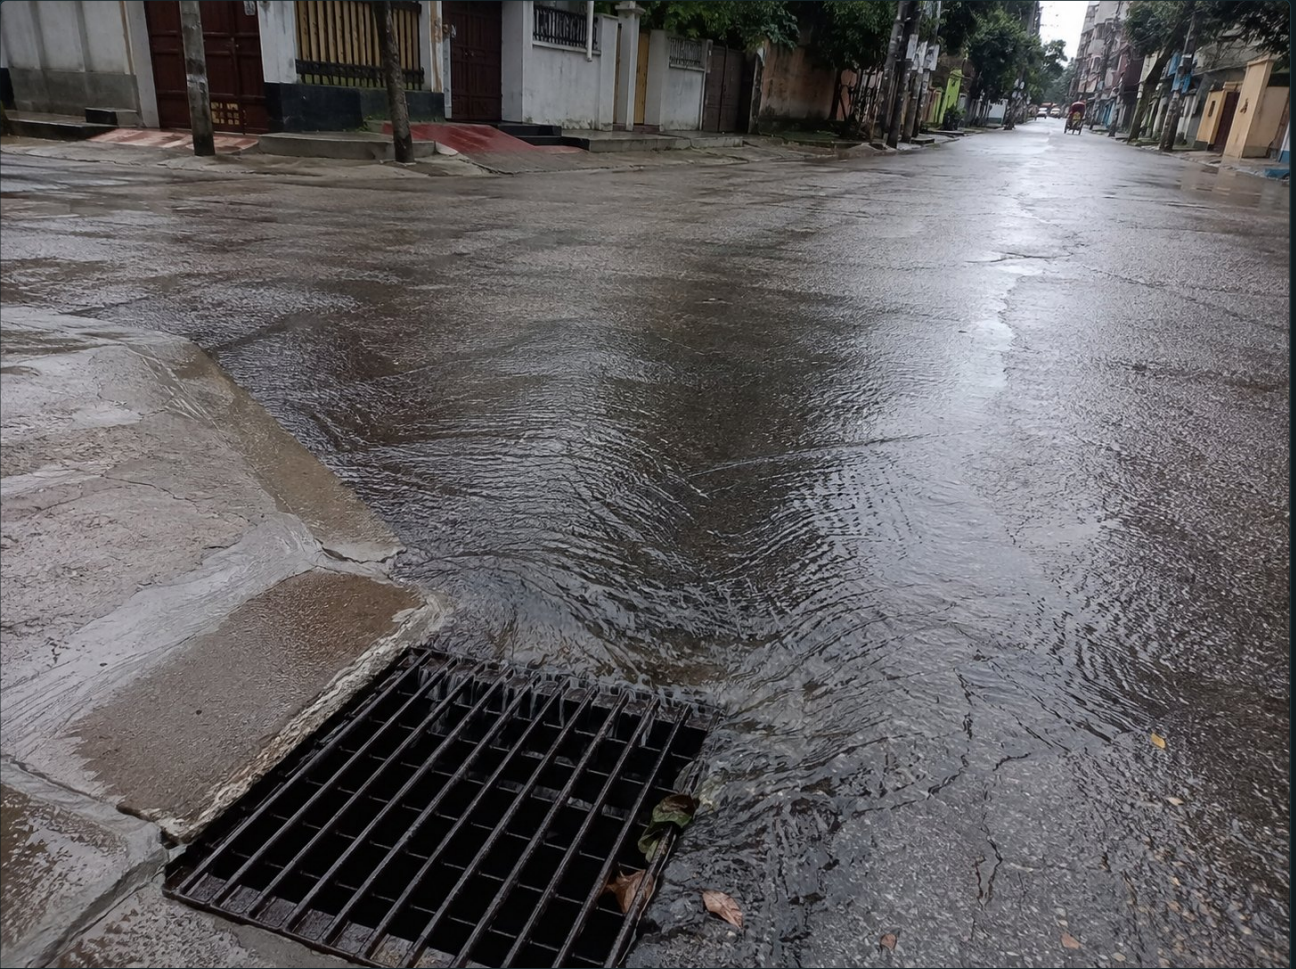
FIG. 5 · 5:20 PM

Water is flowing visibly into an open drain grate; the movement of the water surface is captured as ripples converging at the grate. The road surface around this drain is wet but has no standing water for at least 10 metres in each visible direction. The grate opening appears clear of debris except for a few leaves at one corner.

It cannot show where this drain discharges, or whether it also flowed freely at the peak of the rainfall.
